# Centerville Recreation Building

## ADA Transition Plan

July 2021

Institute for Human Centered Design

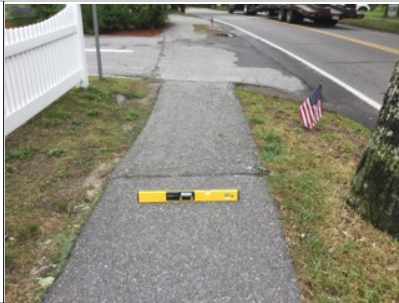
ID	Location	Floor	Room	Element	Type	Photo	Issues	Current Measure	Recommendations	Quantity	Price	Cost Estimation
<b>Approach and Entrance</b>												
<b>Exterior Access Route</b>												
1	Main Street	Ext.		Exterior Access Route	Sidewalk

Cross slope > 1:50 (2.00%)	3.1%	Reduce cross slope to be no steeper than 1:50 (2.00%).	1	240	\$240
2	Route to Secondary East Facing Entrance	Ext.		Exterior Access Route	Walkway

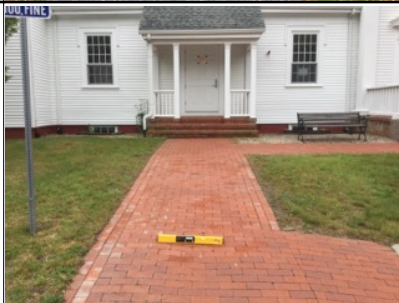
Cross slope > 1:50 (2.00%) Running slope > 1:20 (5%)	5.2% 10.9%	Reduce cross slope to be no steeper than 1:50 (2.00%). Reduce running slope to be no steeper than 1:20 (5%).  (Cost based on a brick paver patch to reduce slope.)	1	416	\$416
3	Route to Secondary East Facing Entrance	Ext.		Exterior Access Route	Exterior

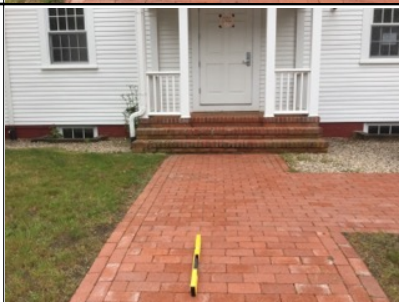
Running slope > 1:20 (5%)	10%	Reduce running slope to be no steeper than 1:20 (5%).  (Cost based on a brick paver patch to reduce slope.)	1	416	\$416
4	Main Street	Ext.		Exterior Access Route	Sidewalk

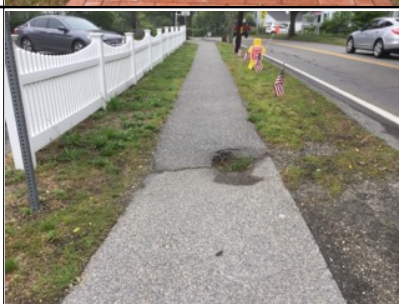
Surface is not stable, firm, and slip-resistant Does not prevent accumulation of water	- -	Repair surface.	1	160	\$160

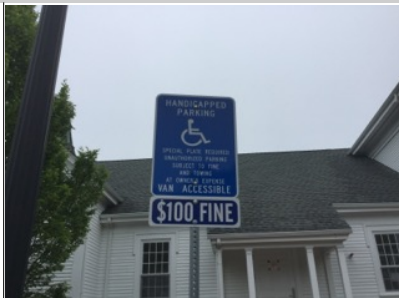
<b>Off-Street Parking Lot or Garage</b>												
5	Parking Lot	Ext.		Off-Street Parking Lot or Garage	N/A

Total # of parking Total # of designated accessible parking spaces Total # of designated van accessible spaces Sign top > 96" above finished grade	13 1 1 103"	Locate sign with the top of the sign 96" above the ground.	1	Labor	\$0

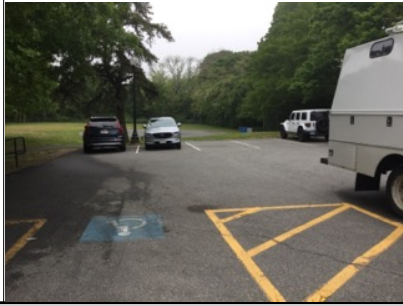
ID	Location	Floor	Room	Element	Type	Photo	Issues	Current Measure	Recommendations	Quantity	Price	Cost Estimation
6	West Side Parking by Path to Softball Field	Ext.		Off-Street Parking Lot or Garage	N/A

Total # of parking Total # of designated accessible parking spaces Total # of designated van accessible spaces Sign does not have the designation "Van Accessible"	11 - 1 -	Add the designation "Van Accessible" to the sign located at the van accessible space.	1	500	\$500
<b>Exterior Ramp</b>												
7	Right Egress Door (South Facing)	Ext.		Exterior Ramp	N/A

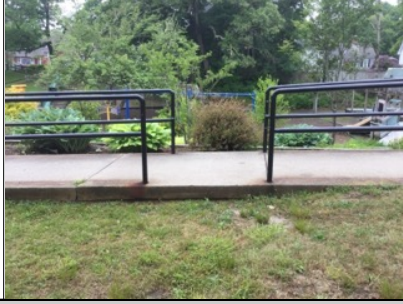
Handrails not continuous where required	-	Provide continuous handrails.  (Cost based on welding extensions on to existing pipe.)	1	284	\$284
<b>Exterior Stair</b>												
8	Egress Stair From Second Floor	Ext		Exterior Stair	N/A

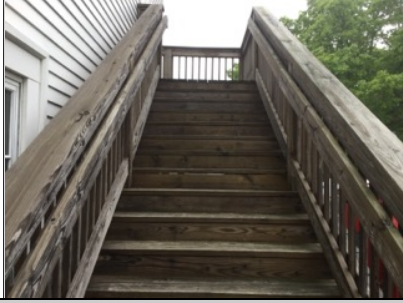
Cross section of handrail is not compliant	-	Provide handrails with 1 1/4" - 2" circular cross sections.  (Cost based on two 30' metal handrails with a complaint cross section.)	1	4440	\$4440

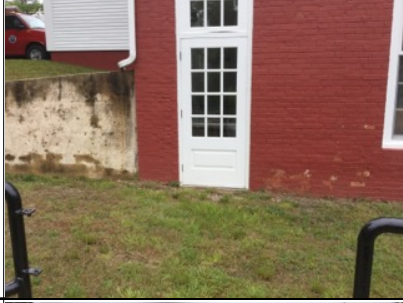
<b>Entrance</b>												
9	Right Egress Door (South Facing)	Ext.		Entrance	Other

Directional sign to accessible entrance not provided	-	Provide a directional sign indicating the location of the nearest accessible entrance.	1	346	\$346
10	Rear Entrance/ Egress	1		Entrance	Secondary Entrance

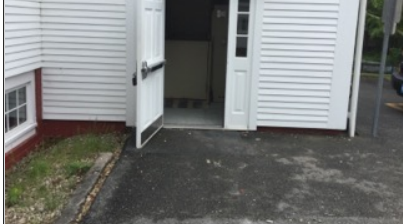
International Symbol of Accessibility not provided Threshold > 3/4" high	- 1"	Provide a sign with the International Symbol of Accessibility (ISA). Alter threshold to be 3/4" high max.	1	496	\$496

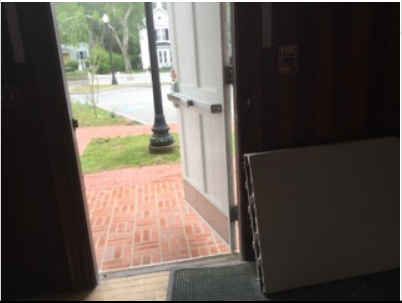
ID	Location	Floor	Room	Element	Type	Photo	Issues	Current Measure	Recommendations	Quantity	Price	Cost Estimation
<b>Emergency Exit</b>												
11	Egress Door	1		Emergency Exit	N/A

Tactile sign not provided at exit	-	Provide tactile exit signs with raised characters and braille at exit doors. Mount signs between 48"- 60" above the finished floor located on the latch side of the door.	1	232	\$232
12	Egress Door	1		Emergency Exit	N/A

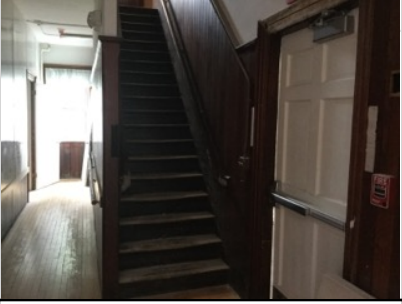
Tactile sign not provided at exit	-	Provide tactile exit signs with raised characters and braille at exit doors. Mount signs between 48"- 60" above the finished floor located on the latch side of the door.	1	232	\$232
13	Rear Entrance/ Egress	1		Emergency Exit	N/A

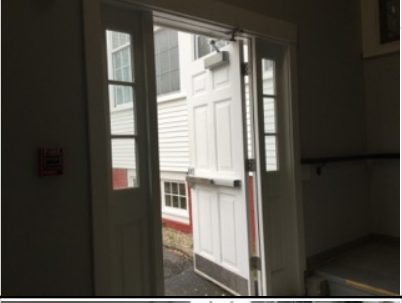
Tactile sign not provided at exit	-	Provide tactile exit signs with raised characters and braille at exit doors. Mount signs between 48"- 60" above the finished floor located on the latch side of the door.	1	232	\$232

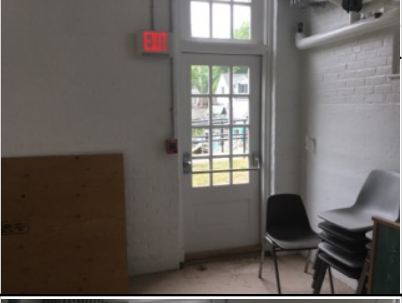
14	Right Egress Door (South Facing)	B		Emergency Exit	N/A

Tactile sign not provided at exit Directional sign to accessible emergency exit not provided	- -	Provide tactile exit signs with raised characters and braille at exit doors. Mount signs between 48"- 60" above the finished floor located on the latch side of the door. Provide a directional sign indicating the location of the nearest accessible emergency exit.	1	232	\$232
15	Left Egress Door (South Facing)	B		Emergency Exit	N/A

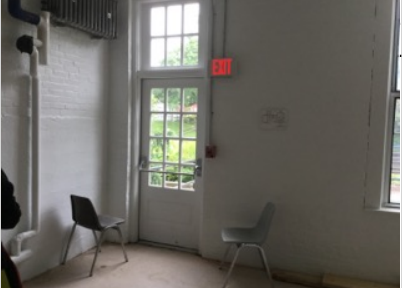
Tactile sign not provided at exit Illuminated Int. Symbol of Acc. not provided (MAAB)	- -	Ensure a tactile exit sign with raised characters and braille is provided at exit door. Mount sign between 48"- 60" above the finished floor located on the latch side of the door. If an illuminated exit sign is provided, ensure that the sign has an illuminated sign with the International Symbol of Accessibility.	1	232	\$232

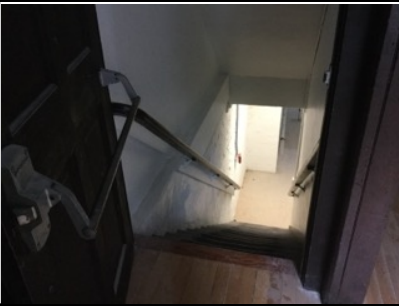
ID	Location	Floor	Room	Element	Type	Photo	Issues	Current Measure	Recommendations	Quantity	Price	Cost Estimation
16	Route to Basement	1		Emergency Exit	N/A

Directional sign to accessible emergency exit not provided	-	Provide a directional sign indicating the location of the nearest accessible emergency exit.	1	232	\$232
17	Side Entrance/Egress	1		Emergency Exit	N/A

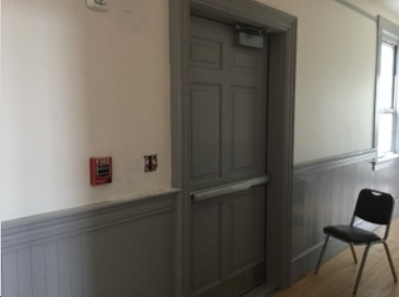
Directional sign to accessible emergency exit not provided	-	Provide a directional sign indicating the location of the nearest accessible emergency exit.	1	232	\$232
18	Right Egress Door (South Facing)	B		Emergency Exit	N/A

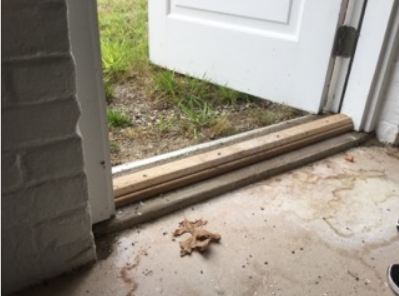
Threshold > 3/4" high	3.75"	Alter the threshold to be 3/4" high max.	1	150	\$150
<b>Access to Goods and Services</b>												
<b>Means of Egress</b>												
19	Summer Activities	1		Means of Egress	N/A

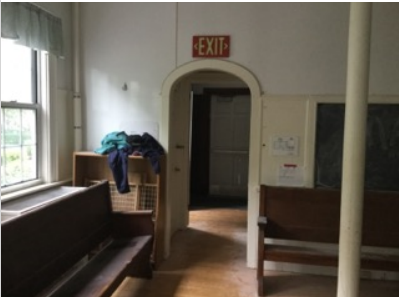
Tactile exit sign not provided	-	Ensure tactile exit signs with raised characters and braille are provided at exit doors. Mount signs between 48"- 60" above the finished floor located on the latch side of the door.	1	232	\$232

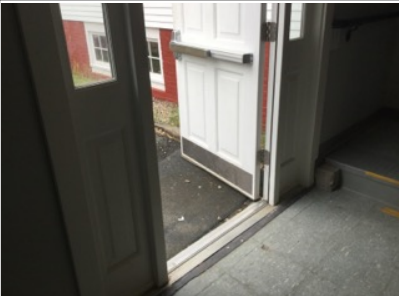
20	Egress to Rear Parking	1		Means of Egress	N/A

Tactile exit sign not provided	-	Ensure tactile exit signs with raised characters and braille are provided at exit doors. Mount signs between 48"- 60" above the finished floor located on the latch side of the door.	1	232	\$232

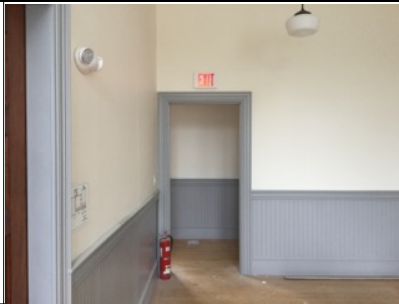
ID	Location	Floor	Room	Element	Type	Photo	Issues	Current Measure	Recommendations	Quantity	Price	Cost Estimation
21	Egress Route	1		Means of Egress	N/A

Tactile exit sign not provided	-	Ensure tactile exit signs with raised characters and braille are provided at exit doors. Mount signs between 48"- 60" above the finished floor located on the latch side of the door.	1	232	\$232
22	Wall Painting on Second Floor	2		Means of Egress	N/A

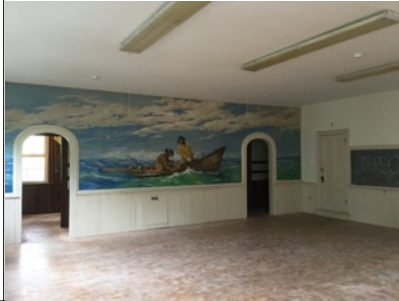
Tactile exit sign not provided	-	Ensure tactile exit signs with raised characters and braille are provided at exit doors. Mount signs between 48"- 60" above the finished floor located on the latch side of the door.	1	232	\$232
23	Main Entrance	1		Means of Egress	N/A

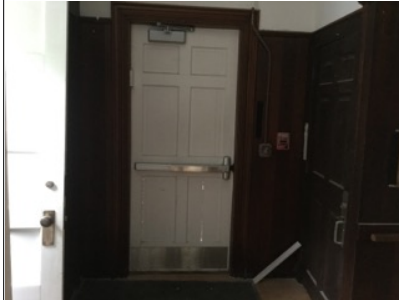
Tactile exit sign not provided Illuminated ISA symbol not provided (MAAB)	- -	Ensure a tactile exit sign with raised characters and braille is provided at exit door. Mount sign between 48"- 60" above the finished floor located on the latch side of the door. If an illuminated exit sign is provided, ensure that the sign has an illuminated sign with the International Symbol of Accessibility.	1	232	\$232

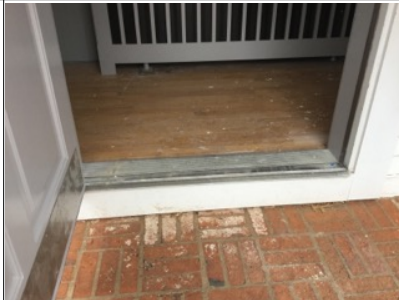
<b>Doors, Doorways, &amp; Gates</b>												
24	Side Entrance/ Egress	1		Doors, Doorways, & Gates	Emergency Egress

Threshold > 1/2" high	6.25"	Provide a temporary ramp.	1	500	\$500
25	Egress East Side	1		Doors, Doorways, & Gates	Emergency Egress

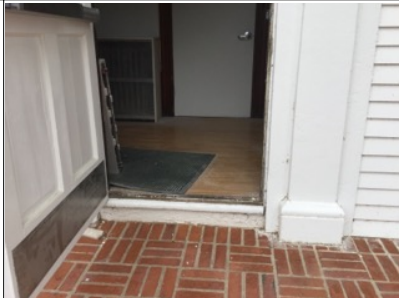
Threshold > 1/2" high	5.25"	Alter the threshold to be 1/2" high max.	1	150	\$150

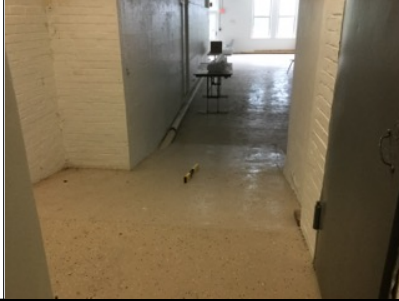
ID	Location	Floor	Room	Element	Type	Photo	Issues	Current Measure	Recommendations	Quantity	Price	Cost Estimation
<b>Ramps</b>												
26	Basement	B		Ramps	Interior

Running slope >1:12 (8.33%) Cross slope > 1:50 (2.00%)	16.5% 2.6%	Reduce running slope to be no steeper than 1:12 (8.33%). Reduce cross slope to be no steeper than 1:50 (2.00%).  (Repair to this ramp might be technically infeasible.)	1	-	\$0
<b>Stairways</b>												
27	Egress to Rear Parking	B		Stairways	Egress

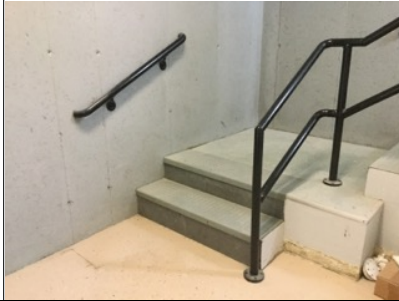
Handrail height < 34" or > 38"	30"	Alter so the handrails are 34"- 38" high above the floor.	1	Labor	\$0
28	Route to Basement	B		Stairways	Other

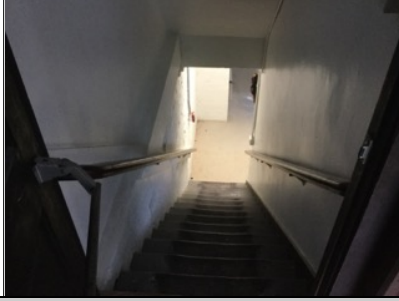
Handrail height < 34" or > 38" Handrails do not extend 12" from stairs	26" -	Alter so the handrails are 34"- 38" high above the floor. Bottom: Ensure handrails extend to one tread depth beyond the last riser.  (Cost for attaching extensions to wood end posts.)	1	332	\$332

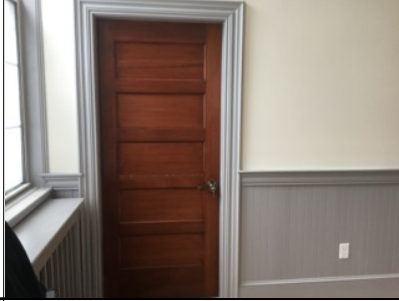
<b>Signage</b>												
29	Toilet Room (Left Side)	1		Signage	Designation

Signage is not provided	-	Locate compliant signage alongside the door on the latch side.	1	232	\$232
30	Men's Toilet Room	B		Signage	Designation

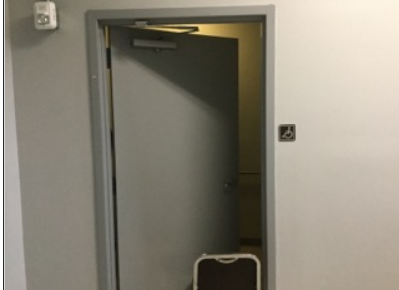
Raised characters not provided on sign Braille not provided on sign	- -	Provide text with raised characters duplicated in Braille on sign.	1	232	\$232

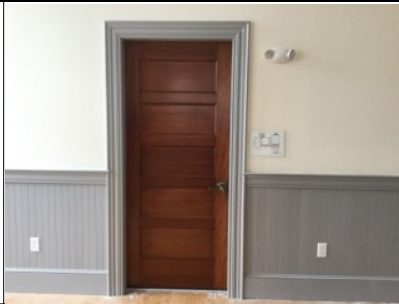
ID	Location	Floor	Room	Element	Type	Photo	Issues	Current Measure	Recommendations	Quantity	Price	Cost Estimation
31	Toilet Room (Right Side)	1		Signage	Designation

Raised characters not provided on sign Braille not provided on sign	- -	Provide text with raised characters duplicated in braille on sign.	1	232	\$232
32	Men's Toilet Room	B		Signage	Designation

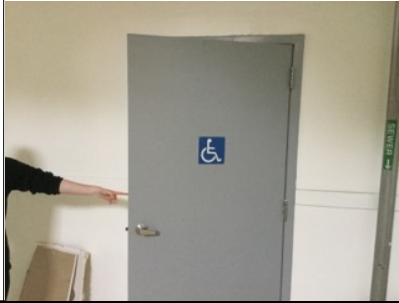
Raised characters not provided on sign Braille not provided on sign Sign not located on the latch side of the door	- - -	Provide text with raised characters duplicated in braille on sign. Locate sign at permanent rooms alongside the door on the latch side.	1	232	\$232
<b>Assembly Area</b>												
33	Summer Activities Room	1		Assembly Area	TV

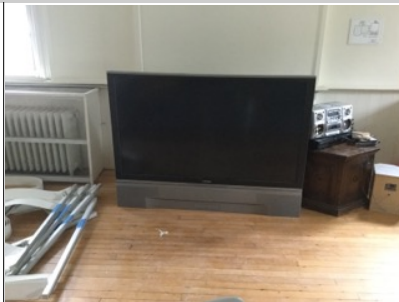
Assistive listening devices not provided	-	If audible communication is integral to the use of the space, provide an assistive listening system.	1	1214	\$1214
<b>Kitchens and Kitchenettes</b>

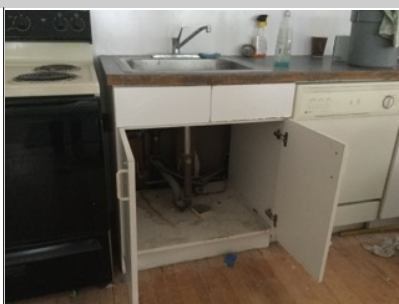
34	Summer Activities Room	1		Kitchens and Kitchenettes	N/A

Knee/toe clearance not provided at sink Sink > 34" high Plumbing underneath is exposed	- 36" -	Provide a sink with knee and toe clearance positioned for a forward approach. Lower sink to be no higher than 34" positioned for a forward approach. Insulate or otherwise configure pipes to prevent contact.  (Renovate if sink is used by members of the public.)	1	-	\$0
35	Summer Activities Room Kitchen	1		Kitchens and Kitchenettes	N/A

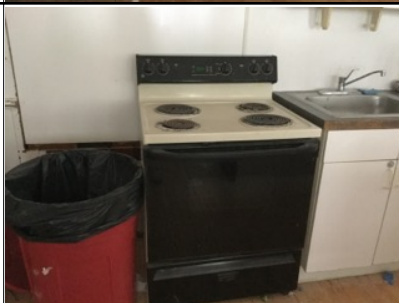
Knee/toe clearance not provided at cooktop Control panels at cooktop not at front Wall oven type not provided	- - -	Provide a cooktop with knee and toe clearance positioned for a forward approach. Provide a cooktop with controls that do not require reaching across burners. Ensure that a wall type oven is provided.  (Renovate if cooktop is used by members of the public.)	1	-	\$0
<b>Toilet &amp; Bathing Rooms</b>

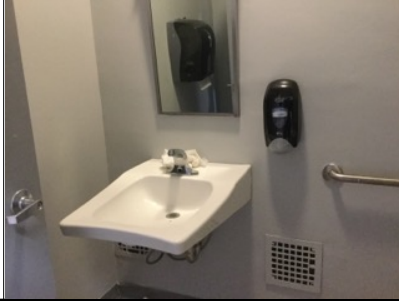
ID	Location	Floor	Room	Element	Type	Photo	Issues	Current Measure	Recommendations	Quantity	Price	Cost Estimation
<b>Lavatory</b>												
36	Men's Toilet Room	B		Lavatory	N/A

Plumbing underneath is exposed	-	Insulate or otherwise configure pipes to prevent contact for at least one lavatory.	1	92	\$92
<b>Single-User Toilet</b>												
37	Men's Toilet Room	B		Single-User Toilet	N/A

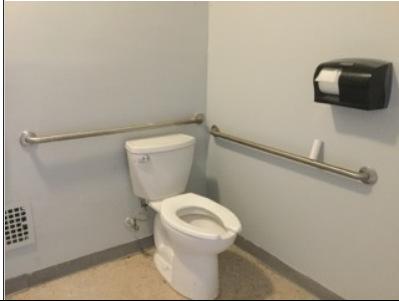
Side or rear grab bar < 33" or > 36" high Toilet paper dispenser is not compliant	31" -	Mount the side grab bar 33"- 36" above the floor. Relocate toilet paper so that it is 24" min. high, located under the grab bar, and between 7" and 9" from the front of the toilet./Replace dispenser as it does not allow continuous paper flow.	1	609	\$609
38	Toilet Room (Right Side)	1		Single-User Toilet	N/A

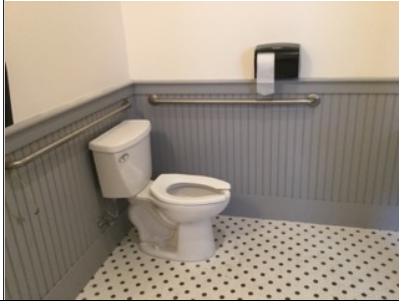
Toilet paper dispenser is not compliant	-	Relocate toilet paper so that it is 24" min. high, located under the grab bar, and between 7" and 9" from the front of the toilet./Replace dispenser as it does not allow continuous paper flow.	1	353	\$353

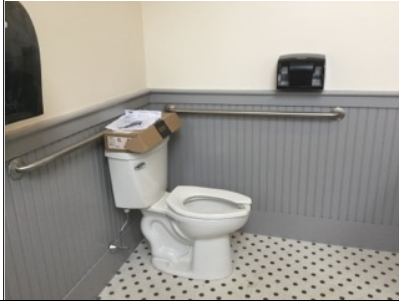
39	Toilet Room (Left Side)	1		Single-User Toilet	N/A

Toilet paper dispenser is not compliant	-	Relocate toilet paper so that it is 24" min. high, located under the grab bar, and between 7" and 9" from the front of the toilet./Replace dispenser as it does not allow continuous paper flow.	1	353	\$353
<b>Toilet Compartment</b>												
40	Women's Toilet Room	B		Toilet Compartment	Accessible Compartment

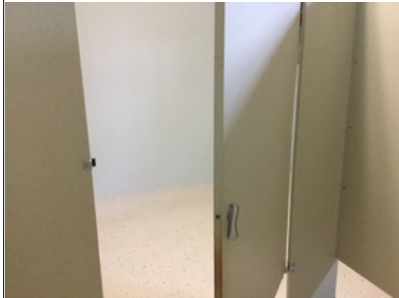
Door has malfunctioning self-closing hinge	-	Repair hinge.	1	Labor	\$0

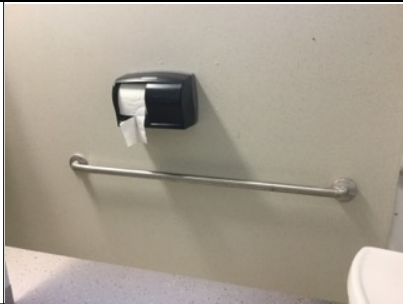
ID	Location	Floor	Room	Element	Type	Photo	Issues	Current Measure	Recommendations	Quantity	Price	Cost Estimation
41	Women's Toilet Room	B		Toilet Compartment	Accessible Compartment

Non-compliant toilet paper dispenser	-	Relocate toilet paper so that it is 24" min. high, located under the grab bar, and between 7" and 9" from the front of the toilet./Replace dispenser as it does not allow continuous paper flow.	1	353	\$353
42	Women's Toilet Room	B		Toilet Compartment	Accessible Compartment

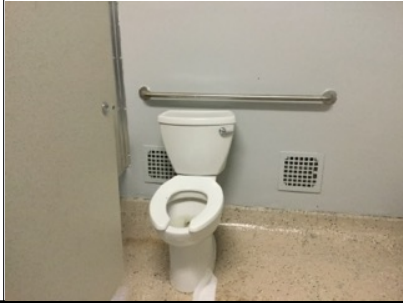
Centerline < or > 18" (MAAB)	- 20"	Relocate toilet so the centerline is 18" from the side wall.	1	2828	\$2828
<b>Urinal</b>												
43	Men's Toilet Room	B		Urinal	N/A

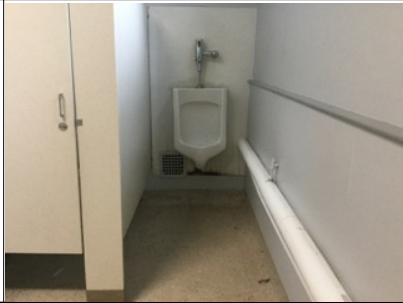
Rim > 17" high	24"	Provide at least one urinal with the rim no higher than 17" above the finished floor.	1	3248	\$3248
<b>Dispensers</b>												
44	Men's Toilet Room	B		Dispensers	Paper Towel Dispenser

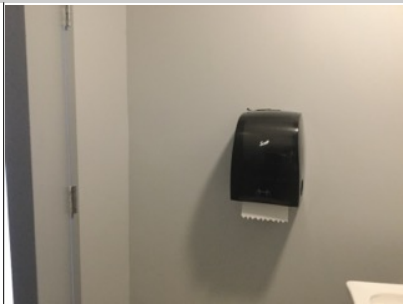
Dispenser acts as a protruding object	9"	Relocate dispenser out of the circulation path or provide a cane-detectible barrier 27" max. above the finished floor.	1	306	\$306

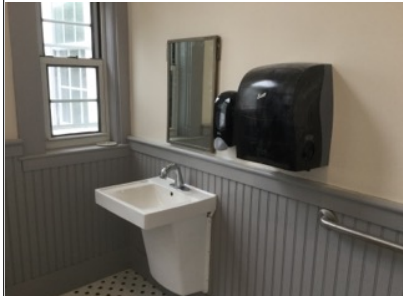
45	Toilet Room (Left Side)	1		Dispensers	Paper Towel Dispenser

Dispenser acts as a protruding object	9"	Relocate dispenser out of the circulation path or provide a cane-detectible barrier 27" max. above the finished floor.	1	306	\$306

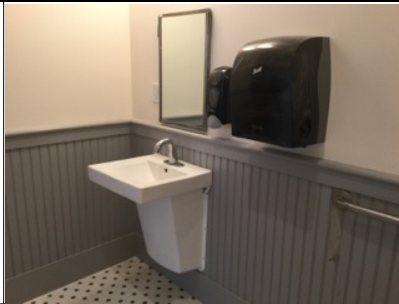
ID	Location	Floor	Room	Element	Type	Photo	Issues	Current Measure	Recommendations	Quantity	Price	Cost Estimation
46	Toilet Room (Right Side)	1		Dispensers	Paper Towel Dispenser

Dispenser acts as a protruding object	10"	Relocate dispenser out of the circulation path or provide a cane-detectible barrier 27" max. above the finished floor.	1	306	\$306
47	Women's Toilet Room	B		Dispensers	Paper Towel Dispenser

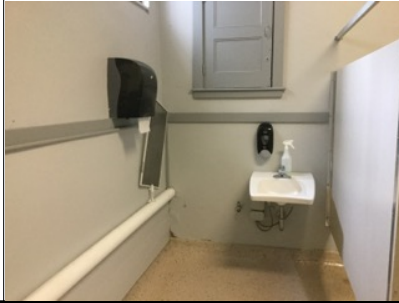
Dispenser acts as a protruding object Plumbing underneath is exposed	9"	Relocate dispenser out of the circulation path or provide a cane-detectible barrier 27" max. above the finished floor. Insulate or otherwise configure pipes to prevent contact for at least one lavatory.	1	398	\$398
<b>Play and Sport Areas</b>												
<b>Field</b>												
48	Softball Field Team Seating Third-Base Side	Ext.		Field	Softball

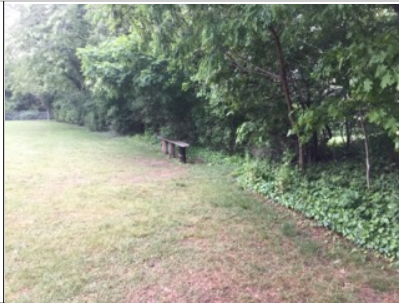
Accessible spaces not provided at team seating	-	Provide a 36" x 48" clear floor space at team seating. Provide an accessible route between the third-base side team seating and the boundary of sport activity at the softball field.  (Cost estimate for a 4' wide min. x 30' long stone dust path connecting the team seating and the boundary of sport activity.)	1	960	\$960

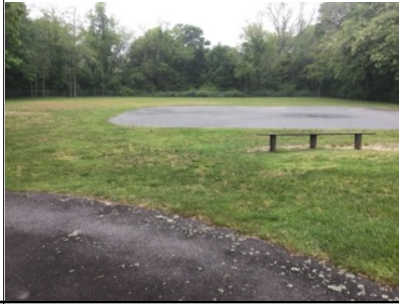
49	Softball Field and Team Seating First Base Side	Ext.		Field	Softball

Accessible spaces not provided at team seating Field not connected to an accessible route	- - -	Provide a 36" x 48" clear floor space at team seating. Provide an accessible route to the boundary of sport activity at the softball field.  (Cost estimate for a 4' wide min. x 60' long stone dust path connecting the existing path to the team seating and to the boundary of sport activity at the softball field.)	1	1920	\$1920
50	Softball Field Team Seating Third-Base Side	Ext.		Field	Softball

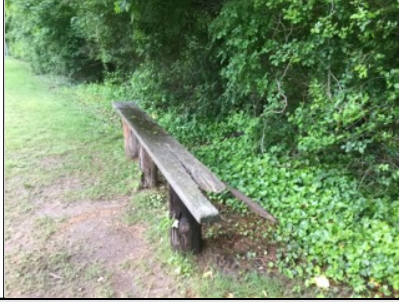
Field not maintained in operable working condition	-	Repair or replace bench for team seating on third-base side of softball field.	1	Labor	\$0
<b>Best Practice</b>

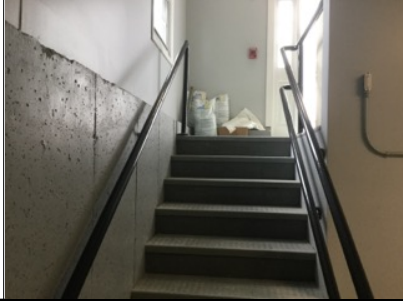
ID	Location	Floor	Room	Element	Type	Photo	Issues	Current Measure	Recommendations	Quantity	Price	Cost Estimation
<b>Egress Stair</b>												
51	Egress to Rear Parking	B		Egress Stair	N/A

Best Practice: Recommend providing contrasting color strips on all stair treads.	1	-	\$0
<b>Stairs</b>												
52	Secondary East Facing Entrance	Ext.		Stairs	N/A

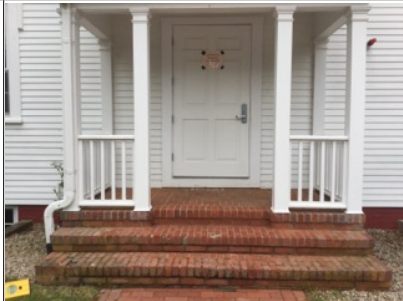
Recommend providing handrails on both sides of stairs that extend 12" min. past the top and bottom riser.	1	-	\$0
53	Egress Door	Ext.		Stairs	N/A

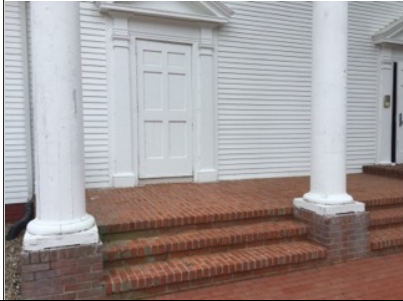
Recommend providing handrails on both sides of stairs that extend 12" min. past the top and bottom riser.	1	-	\$0
<b>Step</b>												
54	Main Entrance	Ext.		Step	N/A

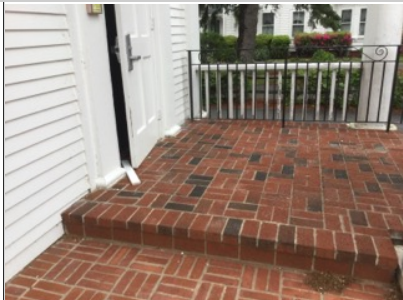
Recommend contrasting color strip at edge of step by the main accessible entrance.	1	-	\$0
<b>Wall Painting</b>												
55	Wall Painting on Second Floor	2		Wall Painting	N/A
