Landfill Office

Town of Barnstable ADA Transition Plan

August 2021

**Town of Barnstable
Landfill Office**

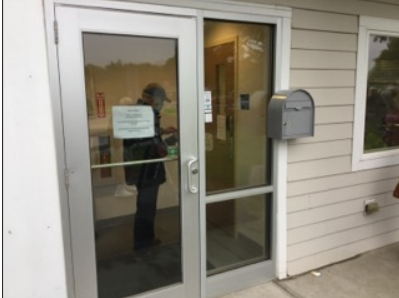
Obstructed by protruding objects	7.25"	Relocate mail box so it does not protrude into the circulation path.	1	Labor	\$0
2	Main Entrance	1		Exterior Access Route	Exterior

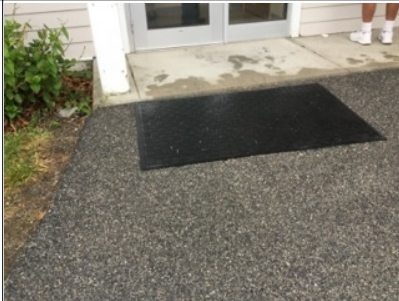
Level changes > 1/4"	1"	Alter change in level to be 1/4" high max.	1	256	\$256
Access to Goods and Services												
Means of Egress												
3	Reception Area to Exit/Entry	1		Means of Egress	180

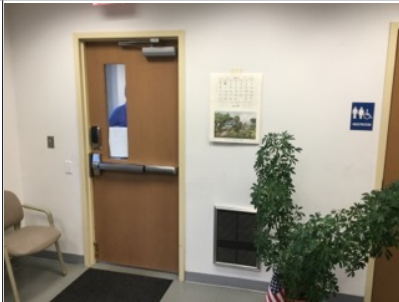
Tactile exit sign not provided	-	Ensure a tactile exit sign with raised characters and braille is provided at exit door. Mount sign between 48"- 60" above the finished floor located on the latch side of the door. Remove chair to maintain the maneuvering clearance at the door.	1	232	\$232
4	Main Entrance/Exit	1		Means of Egress	N/A

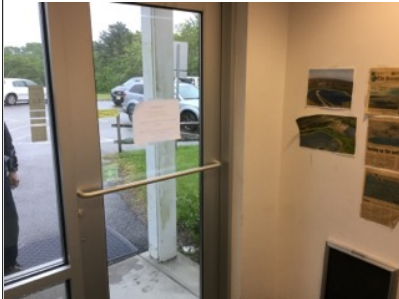
Tactile exit sign not provided Illuminated ISA symbol not provided (MAAB) Door requires > 15 lbs. of force to open	- - 20 lbs.	Ensure a tactile exit sign with raised characters and braille is provided at exit door. Mount sign between 48"- 60" above the finished floor located on the latch side of the door. Provide an illuminated sign with the International Symbol of Accessibility. Adjust closers so door does not require more than 15 pounds of force to open.	1	432	\$432

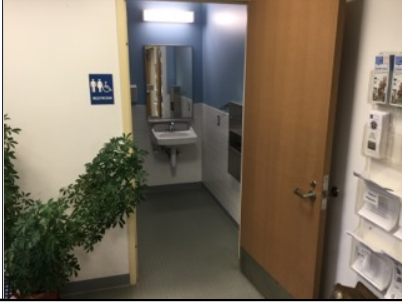
18" min. by 18" min. clear floor space not provided	-	Relocate plant to ensure an 18" min. by 18" min. clear floor space centered on the designation sign is provided.	1	Labor	\$0
Service Counter												
6	Reception Area	1		Service Counter	N/A

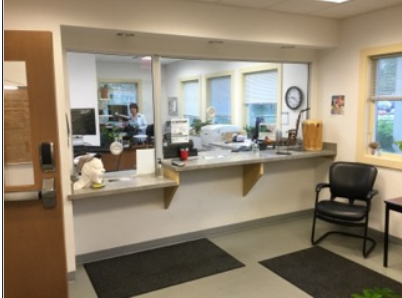
Not maintained in operable working condition	-	Ensure features of facilities and equipment that are required to be readily accessible to and usable by persons with disabilities are maintained in operable working conditions.	1	Labor	\$0
Operable Parts												
7	Reception Area	1		Operable Parts	Other

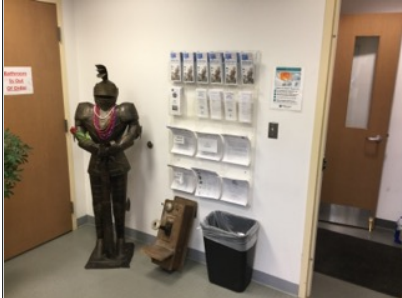
Clear floor space is not provided	-	Relocate trash can to provide a 30" min. by 48" min. clear floor space at information rack.	1	Labor	\$0
Toilet & Bathing Rooms

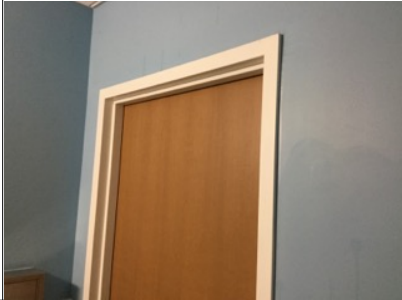
Audible and visible alarms not provided	-	When fire system is updated, ensure that a visible and audible fire alarm is installed.	1	-	\$0
Best Practice

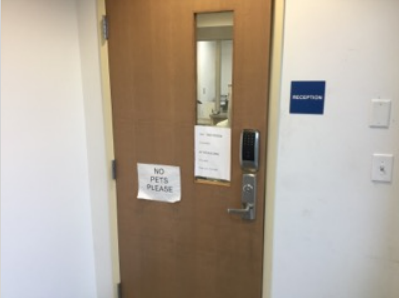
Recommend clarifying on the sign that service animals are allowed in the building.	1	-	\$0
