# Centerville Recreation Building

## ADA Transition Plan

July 2021

Institute for Human Centered Design

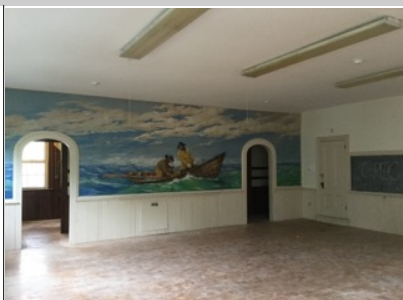
Recommend contrasting color strip at edge of step by the main accessible entrance.	1	-	\$0
<b>Wall Painting</b>												
55	Wall Painting on Second Floor	2		Wall Painting	N/A

- Recommend providing color photos of the Vernon Coleman mural on the second floor at an accessible location in the building and on the Town's web site.
- Recommend providing contrasting color strips on all stair treads.
